# Arboricultural Inventory and Report

City of New Westminster

Active Transportation Network Plan (ATNP)

Year 2 Improvements

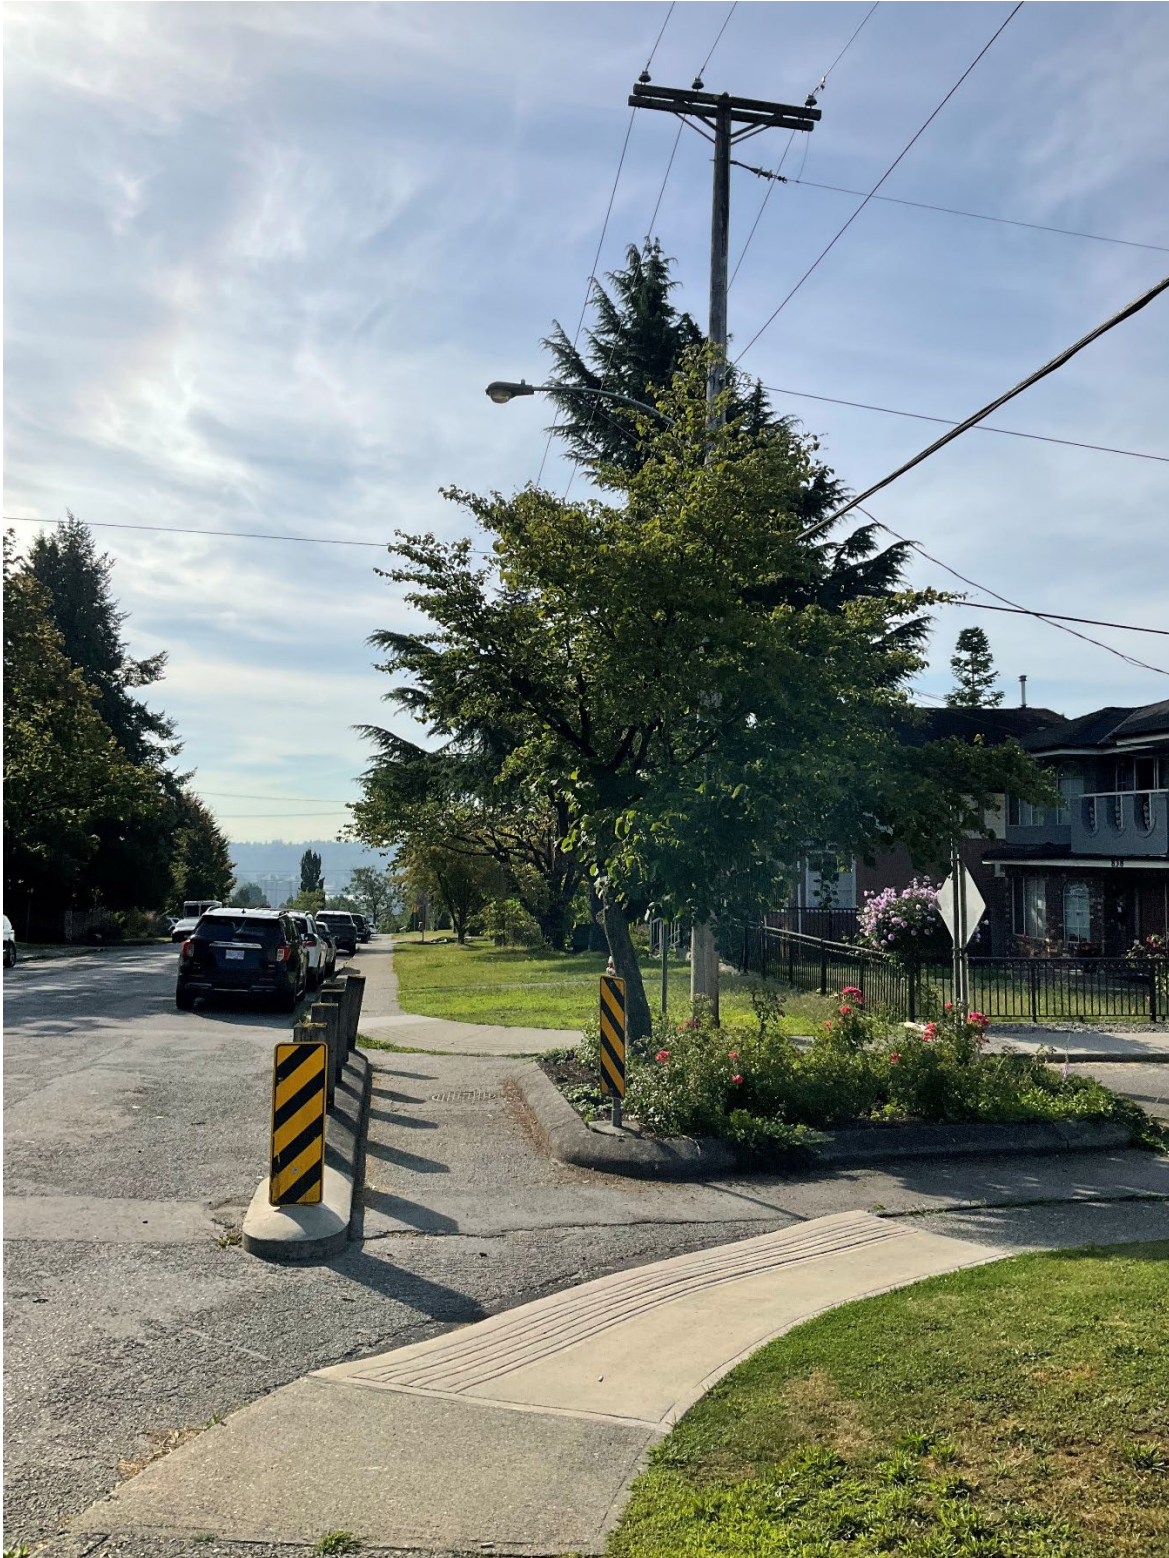
Photo 1. Tree #City12 facing Southeast at Dublin and 13<sup>th</sup> St.

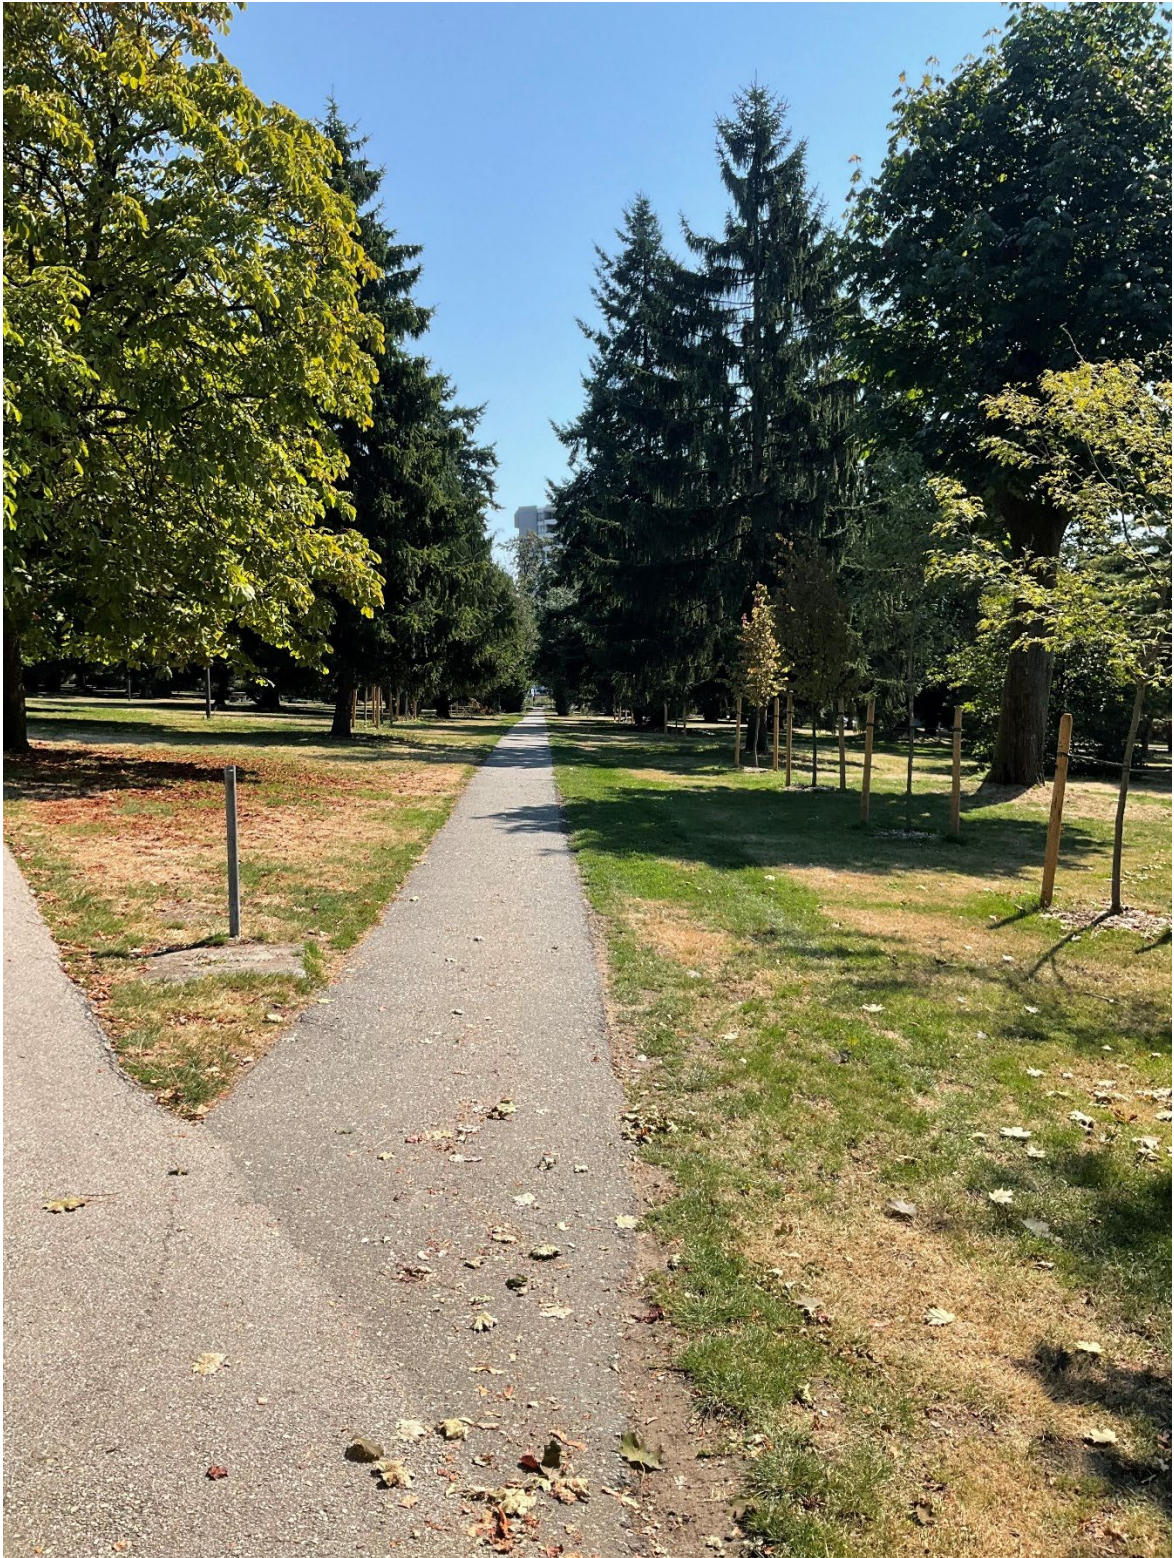
Photo 2. Facing Southeast on paved pedestrian pathway through Moody Park.

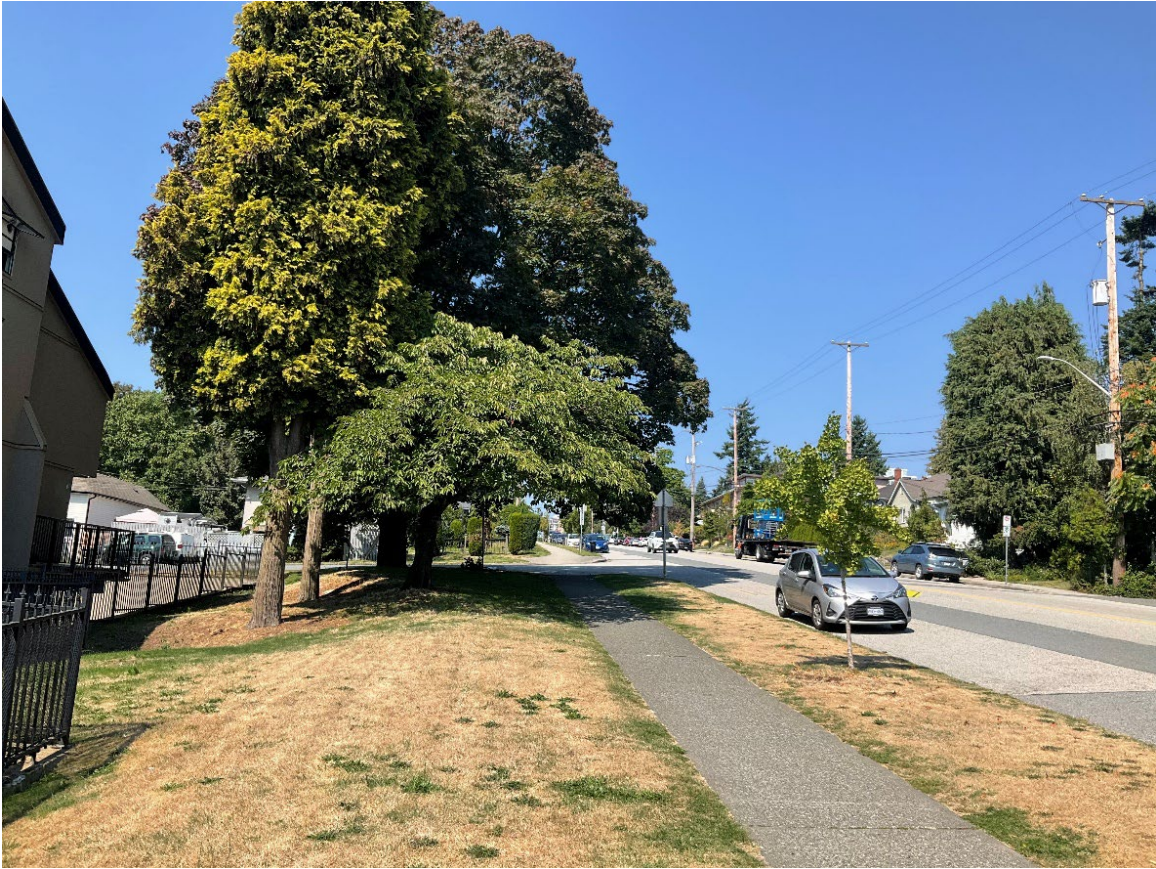
| Surveyed? | Tag # | Location | Species<br>Common Name | Botanical<br>Name | DBH<br>(cm) | Height<br>(m) | Dripline<br>Radius<br>(m) | Health and<br>Structure<br>Rating | Comments | Retention<br>Value<br>Rating | Retain/<br>Remove | Retention/TPZ<br>Comments | *TPZ<br>(m) |
|---|---|---|---|---|---|---|---|---|---|---|---|---|---|
| Yes | City126 | Off-Site | Lawson Cypress | <i>Chamaecyparis lawsoniana</i> | 38 | 15 | 2 | Poor | Growing in grassy area. Codominant at 4m with acute union and crack beginning to form in inclusion. Crown appears healthy. Previously tagged 0733 by DHC. | Low | Retain | Protect and retain per TMP. | 2.28 |

Photo 3. Trees #City124-128 at Milton and 8<sup>th</sup> St, facing Northwest.

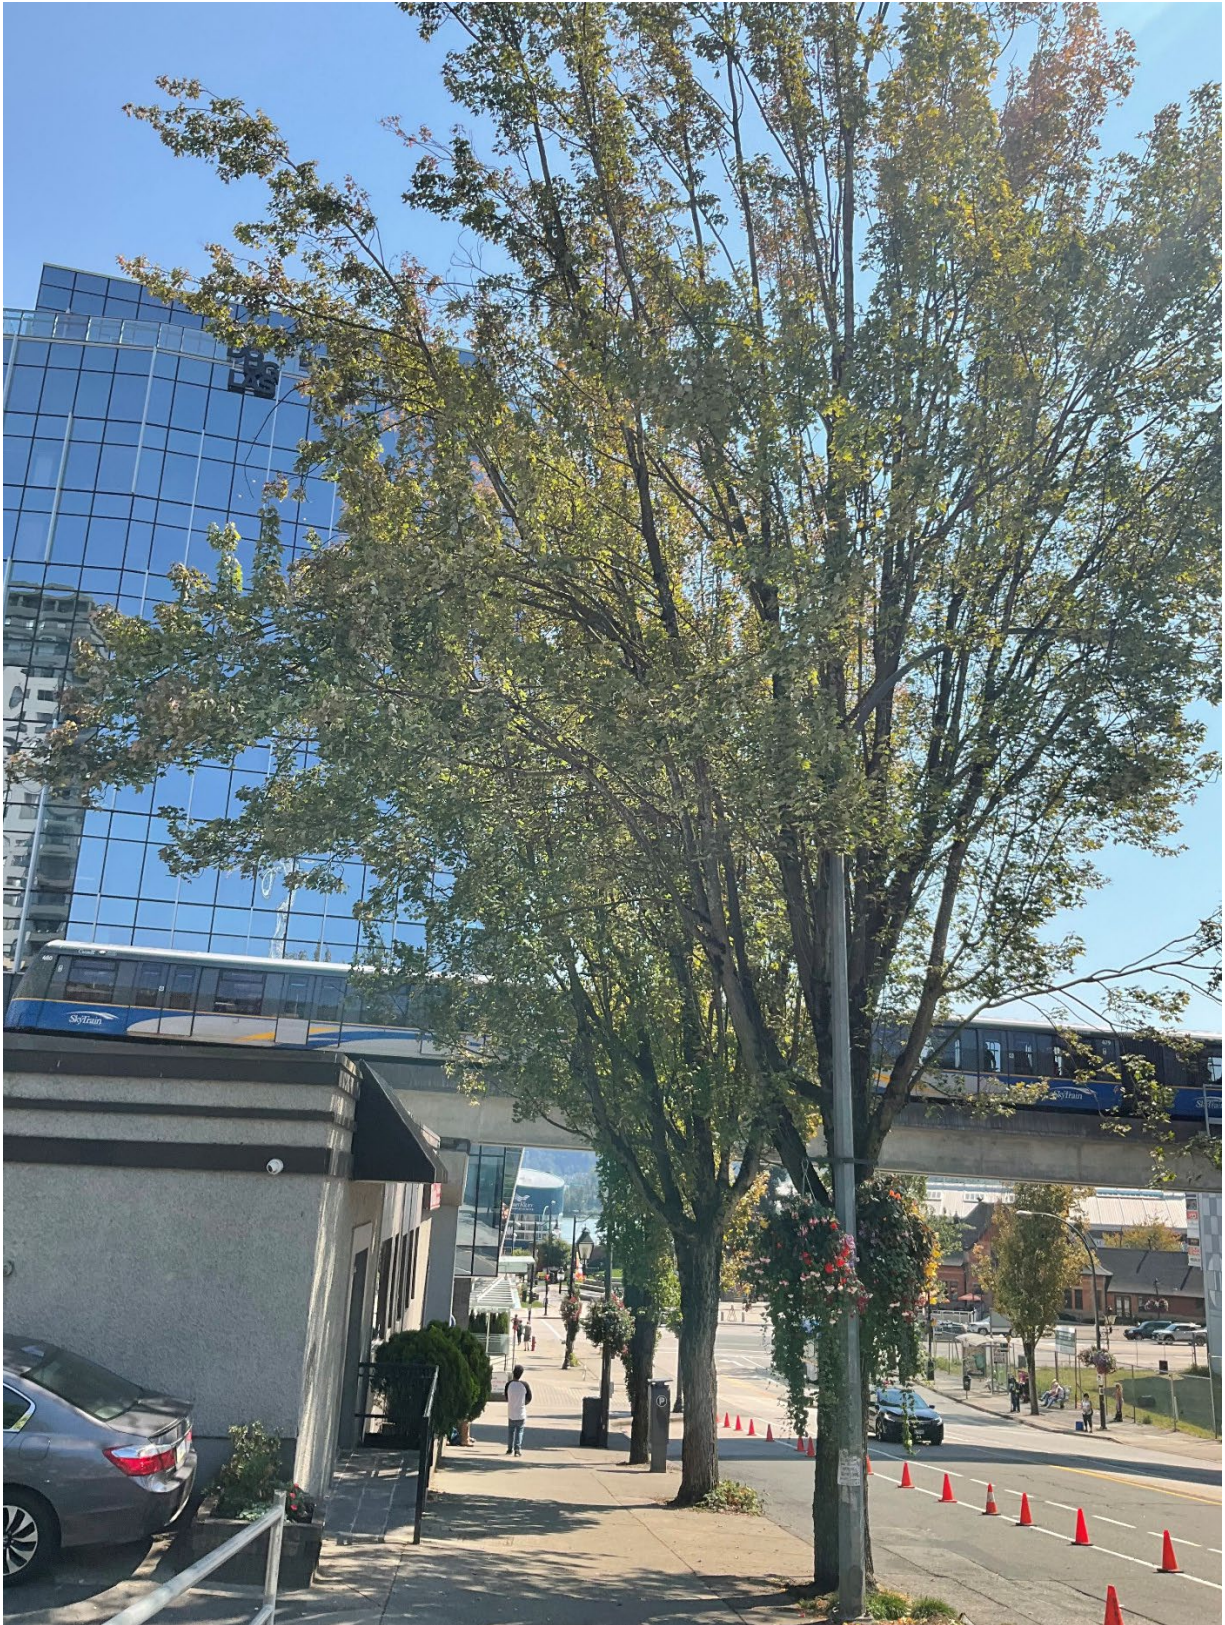
| Surveyed? | Tag # | Location | Species<br>Common Name | Botanical<br>Name | DBH<br>(cm) | Height<br>(m) | Dripline<br>Radius<br>(m) | Health and<br>Structure<br>Rating | Comments | Retention<br>Value<br>Rating | Retain/<br>Remove | Retention/TPZ<br>Comments | *TPZ<br>(m) |
|---|---|---|---|---|---|---|---|---|---|---|---|---|---|
| No | City140 | City | Red Maple | <i>Acer rubrum</i> | 53 | 20 | 4 | Moderate | Growing in highly constrained sidewalk cutout. Notable dieback in crown. On the verge of poor condition. Ensure curb remains in design. | Medium | Remove | In conflict with the proposed lightpost. | 3.18 |

Photo 4. Trees #City140-142 at Carnarvon and 8<sup>th</sup> St, Facing South.

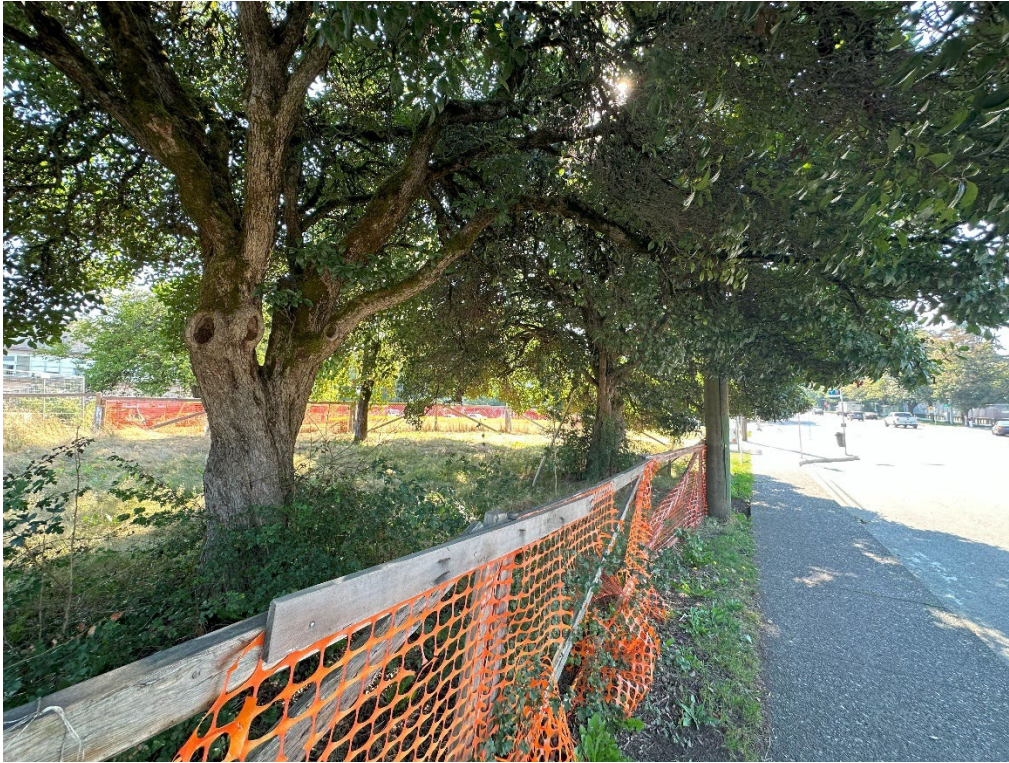
Photo 5. Trees #OS11 & OS12 near Edinburgh and 8<sup>th</sup> St behind TPZ fencing, facing Southeast.

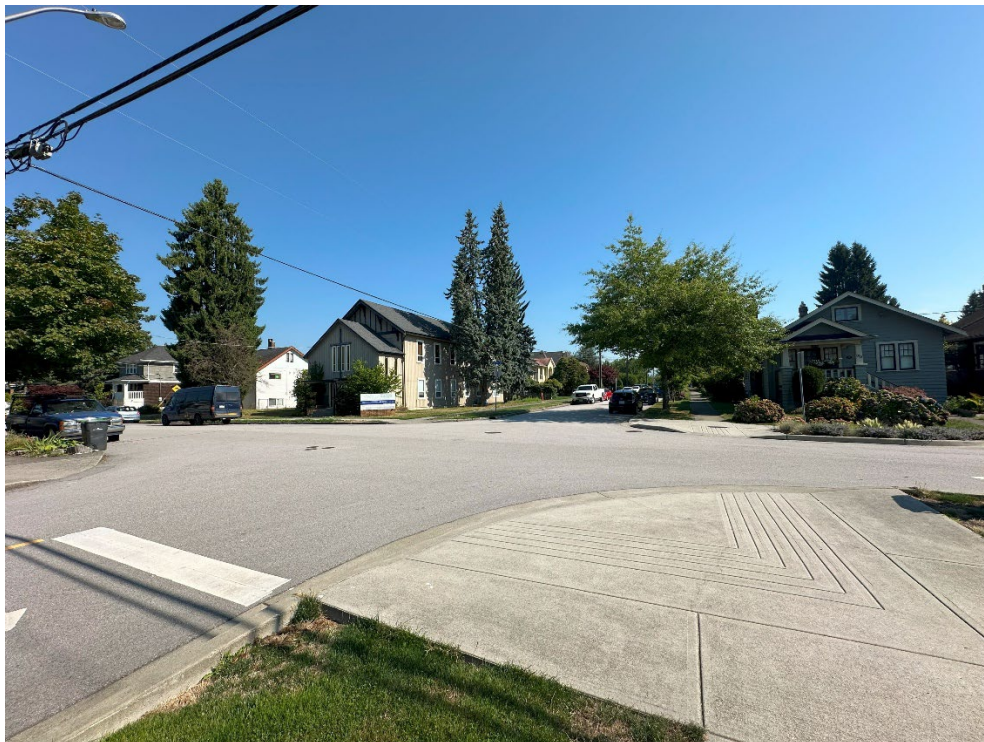
Photo 6. Tree #City59 (right side of road across street). Intersection of London and 10<sup>th</sup> St, facing Northeast.

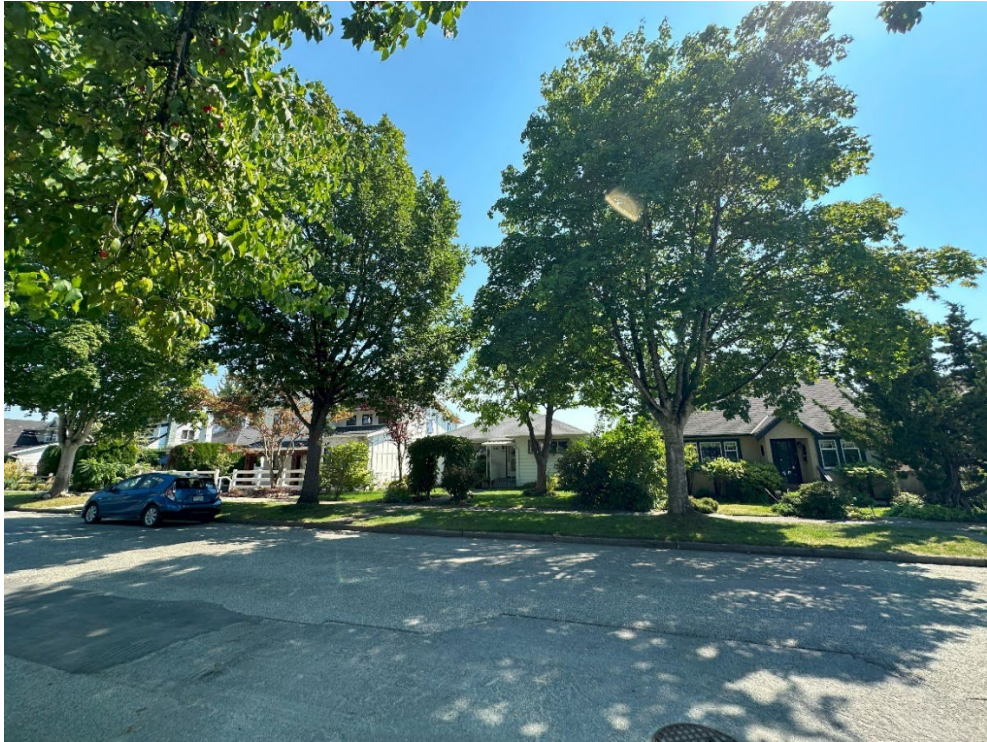
Photo 7. Tree #City164 (right) and City165 (left) near intersection of London and 15<sup>th</sup> St.

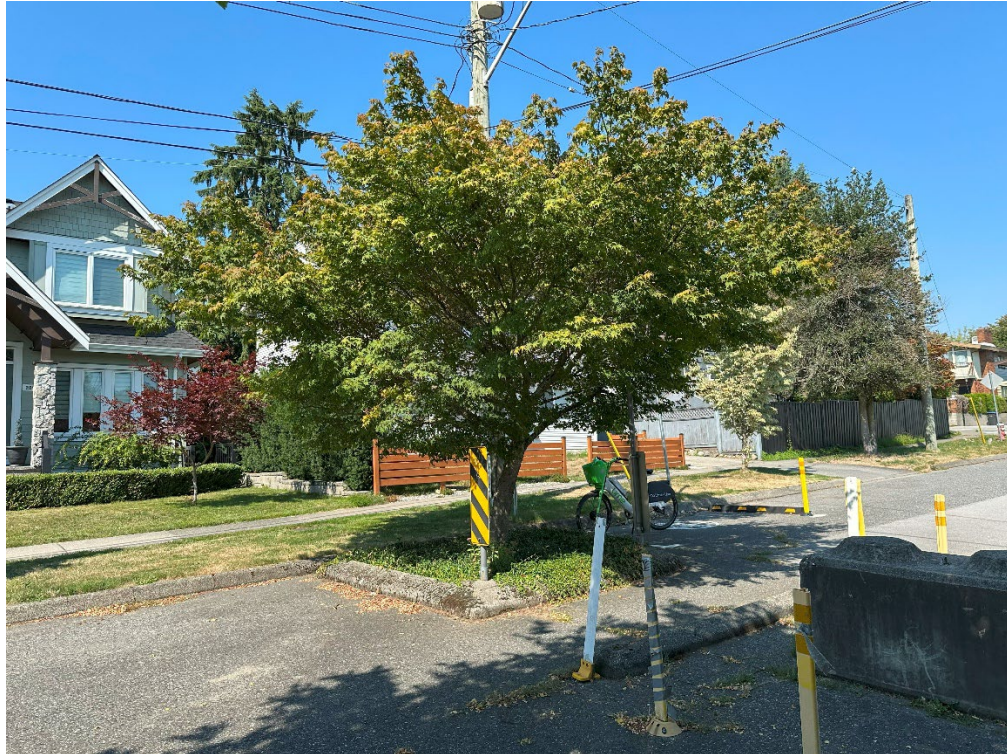
Photo 8. Tree #City185, Japanese Maple in road barrier planting well supporting an active transportation network.
